Tuesday, November 9, 2021

Catherine Redden
Chairperson
Board of Directors
Crowe Valley Conservation Authority

I am pleased to announce that Phase I & II at Callaghan's are now complete. Phase I was executed entirely by volunteers. We used local material from Callaghan's windfall and some hardware donated by volunteers, thus costing nil and is 100% successful. High water levels this summer and fall reduced ATV traffic along the riverbed, but until Phase III is implemented, this unwanted activity will persist.

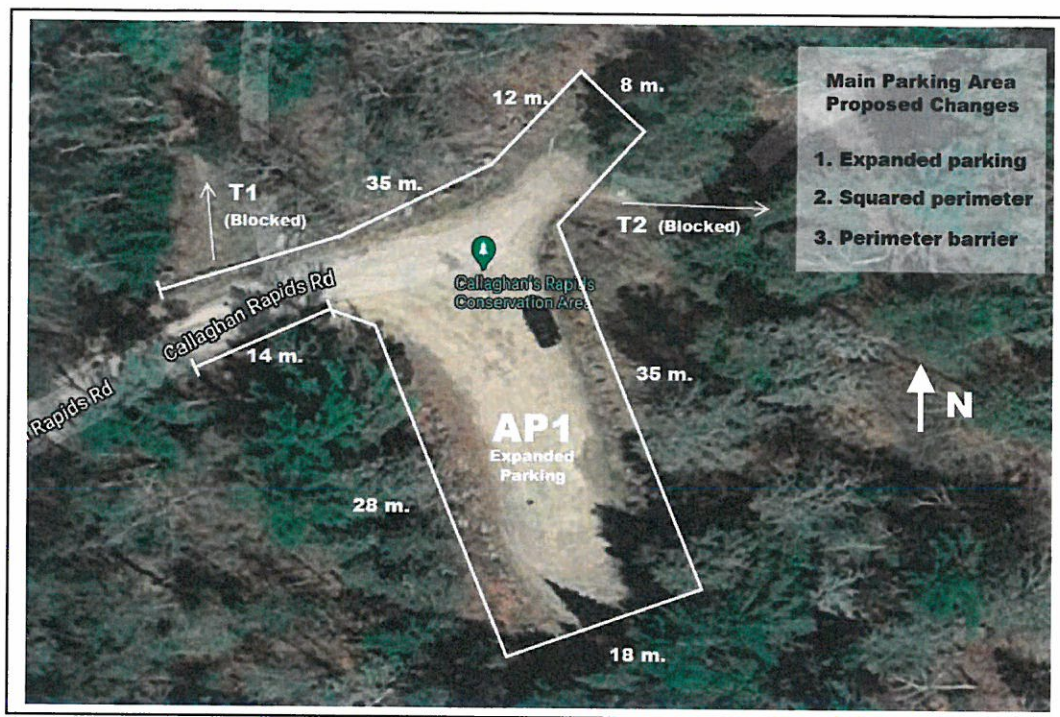
Figure 1: Satellite photo of parking lot prior to modifications

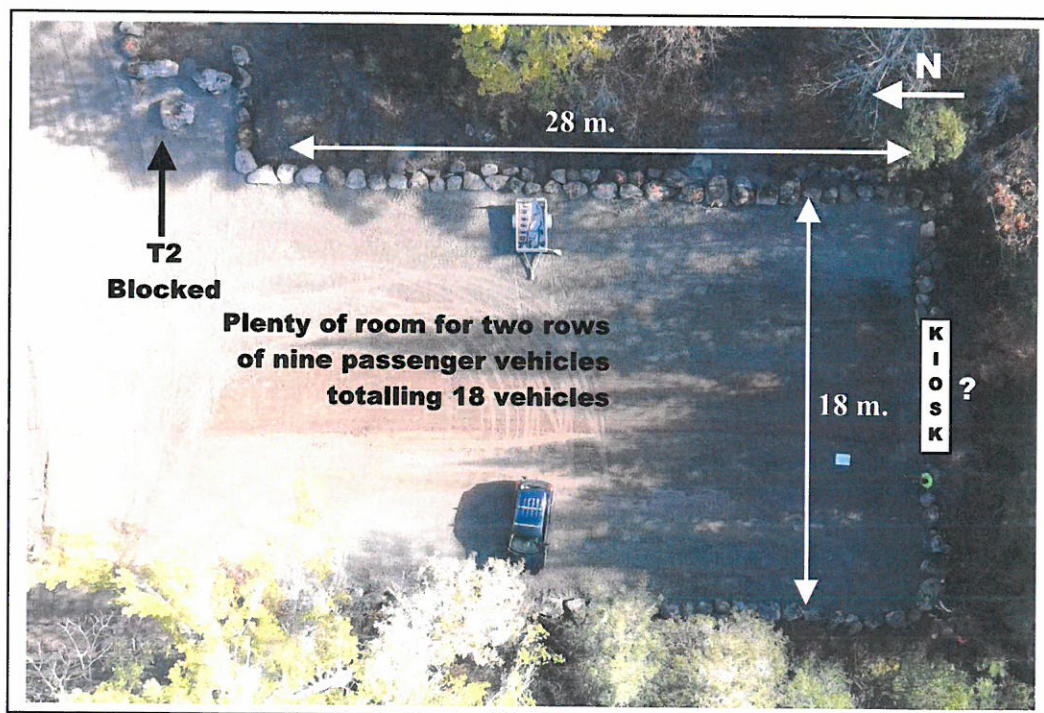
Figure 2: Drone photo of parking lot after modifications
