Barricade Requirements for Callaghan's Rapids Conservation Area

General Introduction

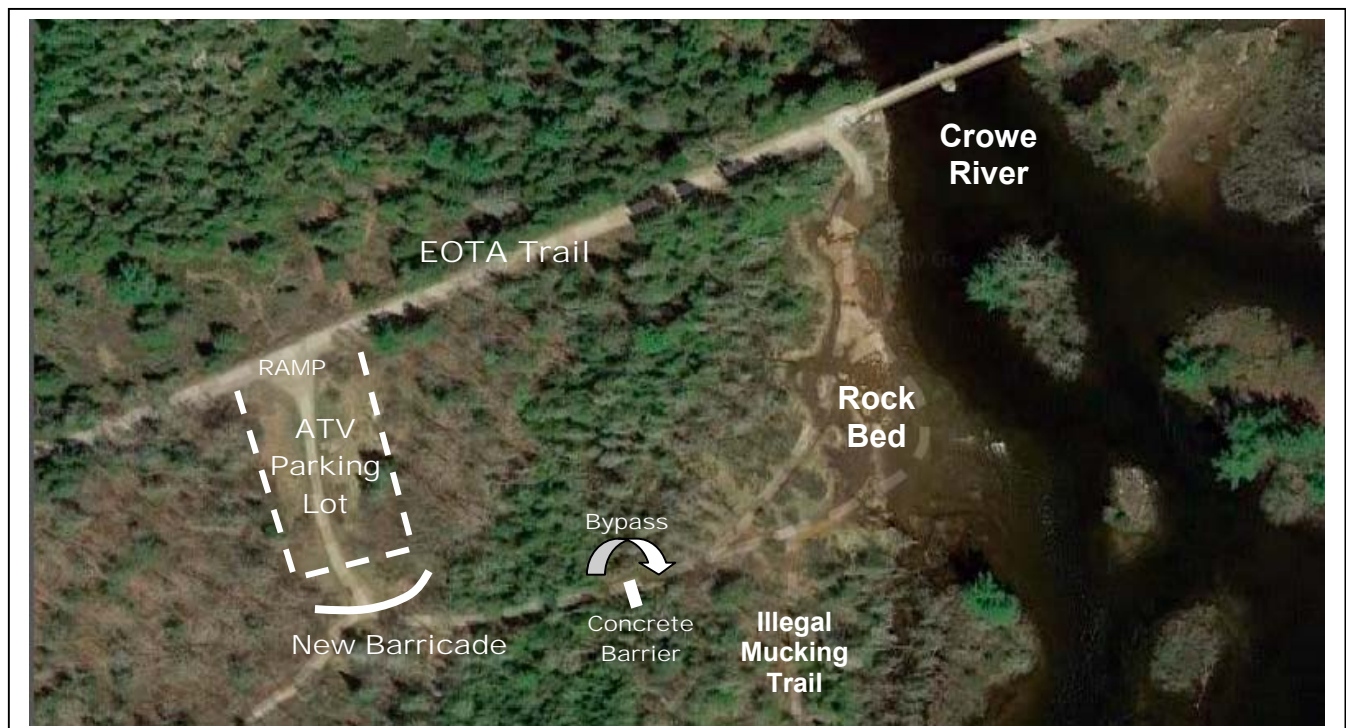
An attempt to prevent entry to the rock bed was made by constructing a concrete barrier along an existing footpath. This was eventually bypassed and there is good evidence that a backhoe or farm tractor with a bucket was used to create this bypass. It is wide enough to accommodate pickup trucks. If there is enough material and time, this bypass should be barricaded as well.

Figure 10: Satellite overview of the proposed ATV Parking Lot & New Barricade

The best location for a barricade is at the entry to the service road below the existing clearing. This clearing would make an excellent parking area for ATVs because it is flat, open and no additional work is required. Relevant signs would need to be posted at the ramp and at the new barricade. This new barricade could also be easily breached within minutes if heavy equipment like a farm tractor was brought in, as was the case (it is suspected), for the breach at the concrete barrier. This is a consequence of four factors:

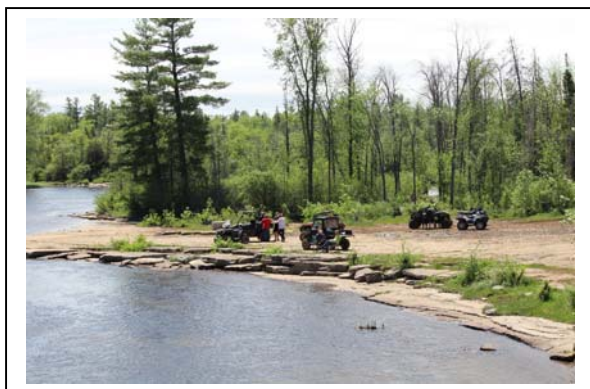
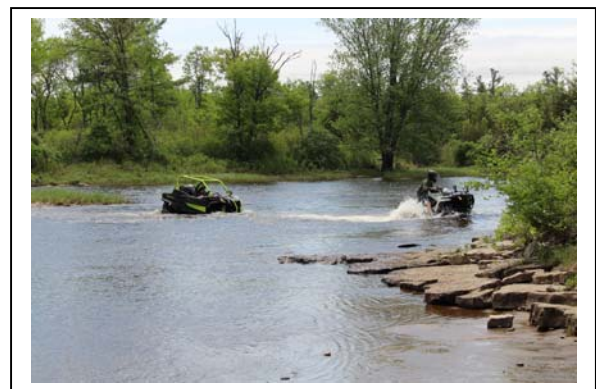
PS: The OPP was scheduled to patrol the area on Saturday, May 22, 2021. They did not show up. Marc Forget erected two signs that prohibited unauthorized motor vehicles. They were destroyed. The pictures below show ATV activity at Callaghan's at noon on Sunday May 23, 2021.
