Economic Development Cooperative of North Kawartha
Crowe Valley Conservation Authority Board Meeting Delegation

April 21, 2022 (via Zoom)

Thank you for the opportunity to address the CVCA Board regarding floodplain determination on Chandos Lake on behalf of the Economic Development Cooperative of North Kawartha.

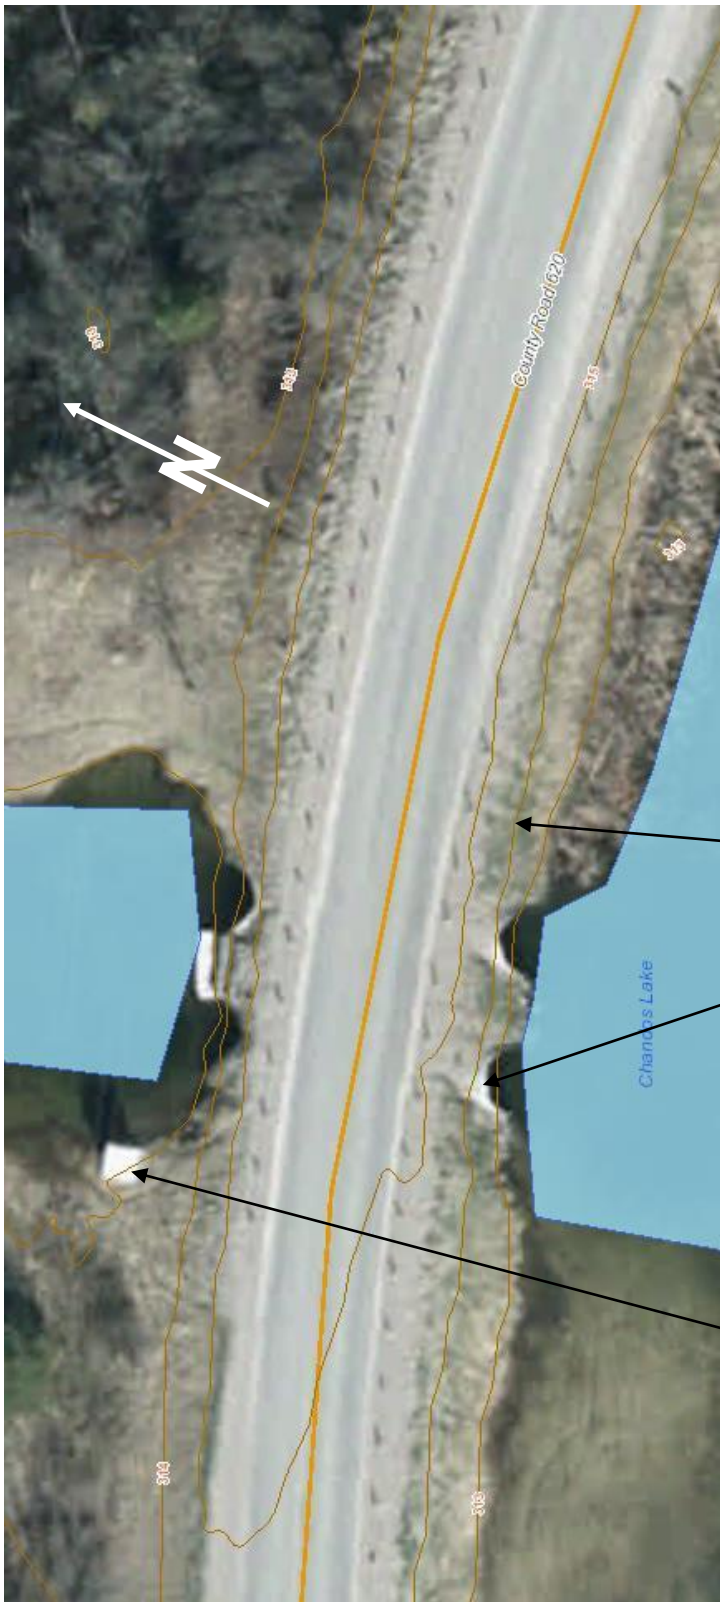
LiDAR map of County Road 620 at Chandos Lake Culverts

LiDAR contour line = 314 masl

South end of west culvert

CVCA began addressing Chandos Lake floodplain issues when it chose to use Peterborough County's GIS LiDAR mapping as the basis for analysis. However, the CVCA water level gauge was not calibrated to the LiDAR contours, thus making the 30+ year history of water levels incompatible with the LiDAR contours. On March 22, 2022, using the CR 620 culverts' LiDAR elevation (see attached LiDAR map), the gauge read 1 metre higher than the actual water level. This finding supports the many anecdotal accounts of Chandos Lake water levels.
